Manhole Inspection Summary

Manhole # S25GG_045MH

Location Address: **1831 ETING ST**

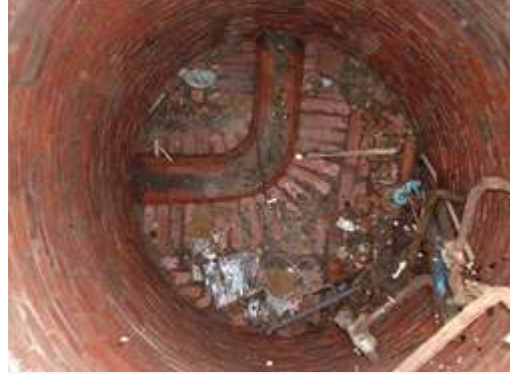
Top View

Corroded steps. Evidence of surcharge - Bench debris. Channel debris.

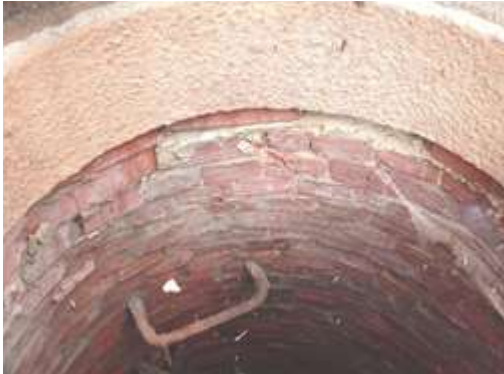
Defect

Frame leaks. Adjustment deterioration, cracks and infiltration. Barrel infiltration.

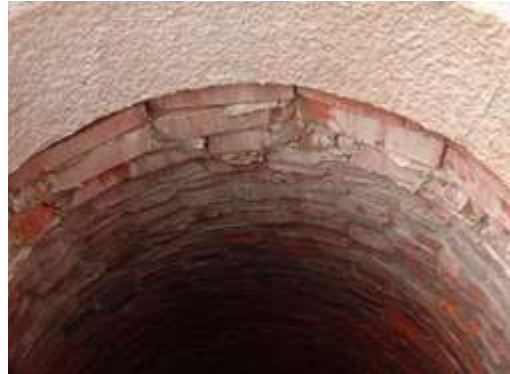
Defect

Frame leaks. Adjustment deterioration and infiltration. Barrel infiltration.

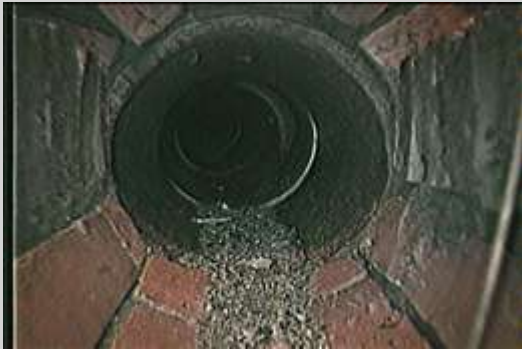
8 in. Circular Gravity Sewer Pipe Out @ 12 O'Clock

Deposits: ☐ None ☒ **Mud** ☐ Sludge ☒ **Debris** ☐ Grease

Silt Depth: **0** (in.) Deposits Extent: **Light**

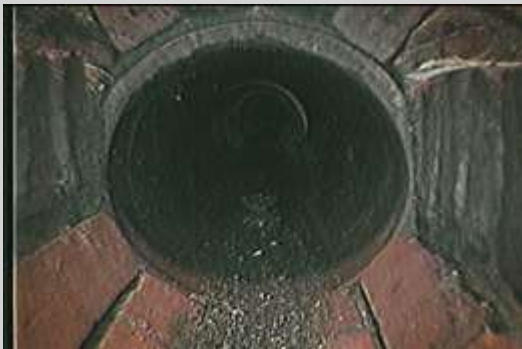
8 in. Circular Gravity Sewer Pipe In @ 9 O'Clock

Deposits: ☐ None ☒ **Mud** ☐ Sludge ☒ **Debris** ☐ Grease

Infiltration: **None** Pipe Seal Cond: **Cracked**
